Failure of Distal Femoral Locking Plate: Case Report

Abstract: The Less Invasive Stabilization System (LISS) and titanium distal femoral locking compression plate (DF-LCP) was designed by the AO Group to combine the advantages of both interlocked intra-medullary nailing and biological plating techniques in one system. The stiffness of the construct is similar to a 95° condylar plate, dynamic condylar screw, or condylar buttress plate.

We report a case of the DF-LCP and screw breakage. Early weight bearing and lack of callus consolidation precipitated failure of the implant. Non-weight bearing and early autologous bone grafting may be indicated in open distal femoral fractures.

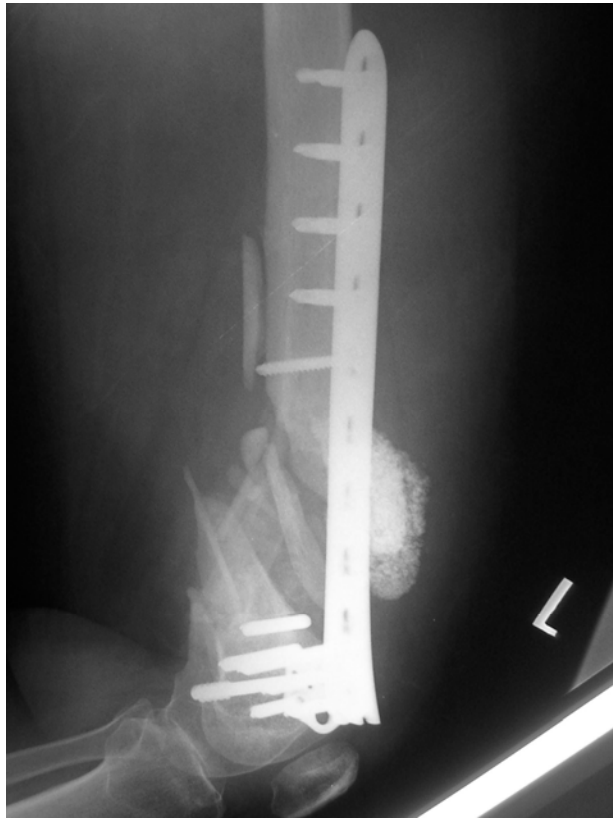
Figure 1: Broken implant x-ray.

Radiographs revealed plate and screw breakage at the distal femoral fixation part (Figures 1 and 2). Revision of the plate fixation and bone grafting with local intra-medullary cortical struts and cancellous chips was done (Figure 3). The previous bone substitute had not formed any callus and was removed. There was no obvious loosening of the implant but there was blackish discolouration of fibrous tissue over the screws - pathological investigation reported it as consistent with black dye deposition. The broken implants were tested by the Dr. h.c. Robert Mathys Stiftung Foundation and the failure was attributed to overload and fatigue.

In our patient, a combination of factors led to the breakage. Although bone grafting was performed, the bony deficit persisted. In addition to that, she started weight bearing before fracture consolidation. Plate breakage occurs when bony defects are radiographically evident [3]. Lack of callus consolidation precipitated cyclical overloading of the implant, which eventually failed.

The fatigue resistance of titanium is inferior to stainless steel and fatigue plate fractures occur at the sides of a screw hole. The titanium screws also show typical fatigue fractures at the junction of the shaft and head. This section is subjected to a combination of loads, including torque and bending.

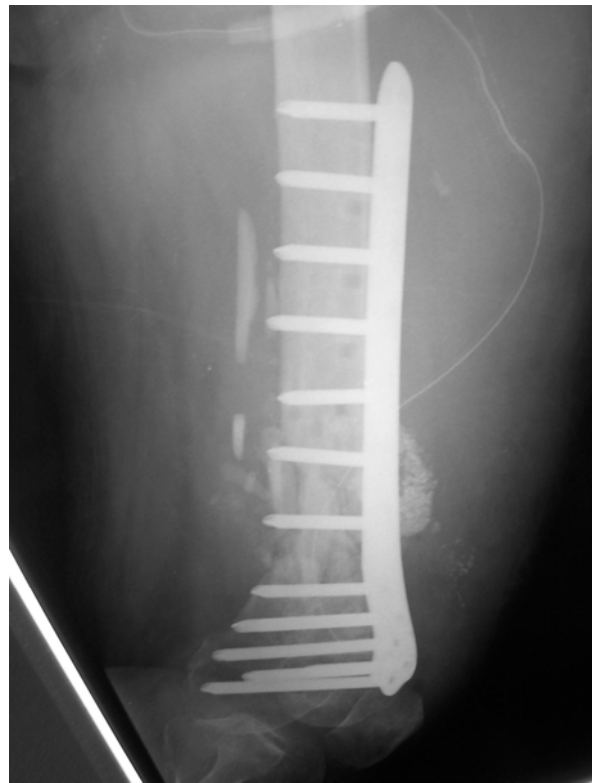
Figure 3: Immediate post revision.
