Failure of VariAx[®] Distal Radial Locking Plate: Fractographic Analysis and Report of Two Cases

Paras Mohanlal¹, Christopher James¹, Amit Tolat^{*1}, Ambrose Taylor² and Andrew Amis^{2,3}

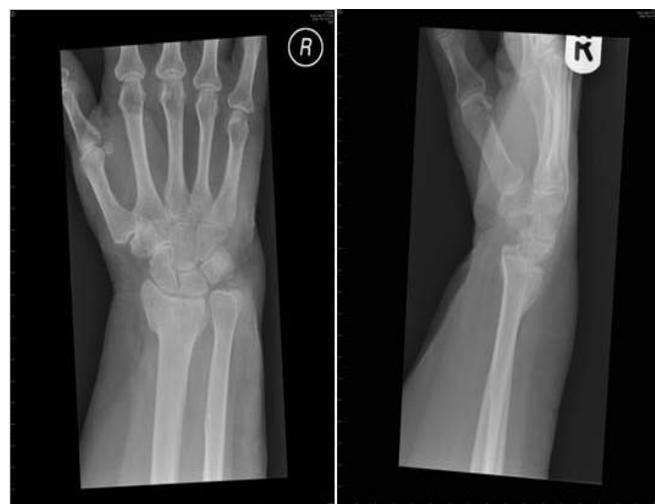
A 76-year-old patient was referred with wrist pain and stiffness following a distal radial fracture sustained 2 years ago. She had initially been treated non-operatively and did not respond to a period of aggressive physiotherapy. Radiographs showed a malunited distal radial fracture with shortening of about 14 mm and dorsal angulation of 25 degrees (Figure 1).

Figure 1: Pre-operative anteroposterior and lateral wrist radiographs of case 1, showing malunited distal radial fracture with shortening and dorsal angulation.

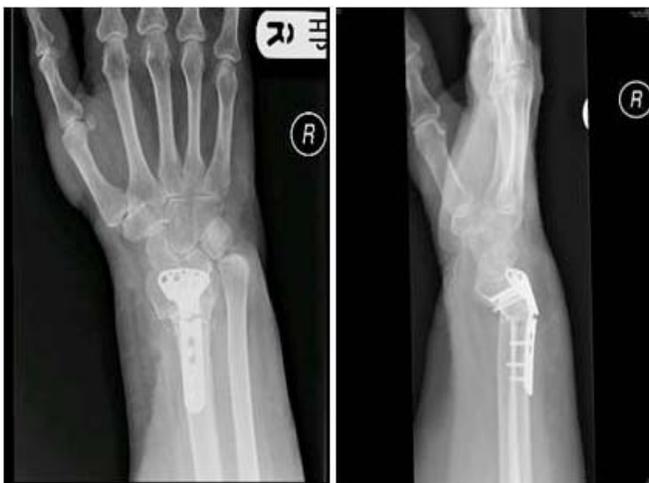
However, she presented at 6 weeks with spontaneous onset of wrist pain and radiographs showed implant failure through the unfilled screw hole at the osteotomy site (Figure 3). She underwent revision surgery with retrieval of the broken implant and re-fixation with a standard non-locking plate (Synthes GmbH, Solothurn, Switzerland).

Figure 3: Radiographs demonstrating broken VariAx distal locking plate at the level of the unfilled screw hole (case 1).

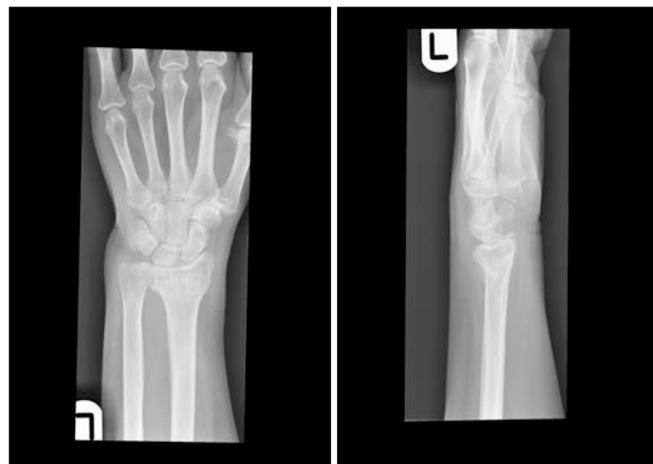
shortening of 8 mm and dorsal angulation of 20 degrees (Figure 4). She had wrist pain and loss of palmar flexion and hence a corrective osteotomy was planned.

Figure 4: Pre-operative anteroposterior and lateral radiographs of the wrist (case 2) showing malunited distal radial fracture.

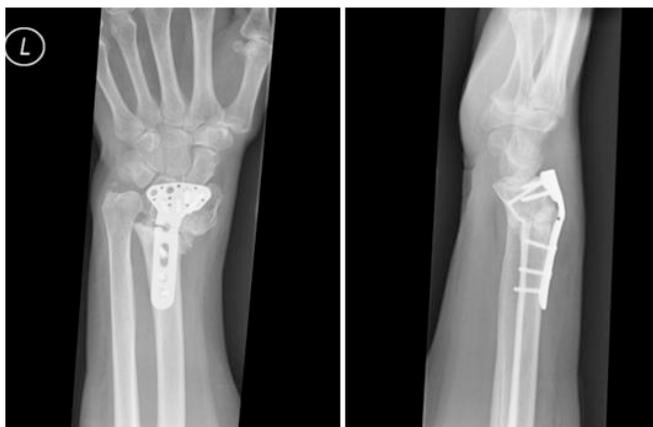
Figure 6: Anteroposterior and lateral radiographs of the wrist (case 2) showing broken VariAx plate at the level of unfilled screw hole close to the osteotomy site.

As the patient continued to be symptomatic, the plate was removed and during surgery the osteotomy was found to be healed. She improved following a course of physiotherapy and at the latest follow-up visit, she was pleased with her recovery and was able to do all her activities of daily living without restrictions and was back at work. The harvested plate was also examined visually and by SEM.

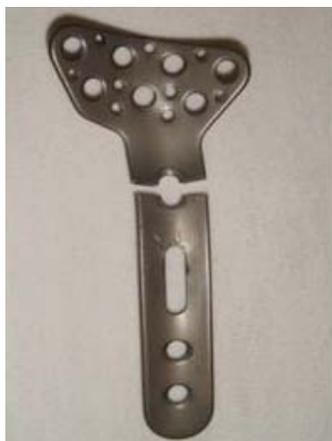
The failures of the two plates were essentially identical. There had been a transverse fracture across the narrow bridges at the sides of the screw hole (Figure 7). The plates had not undergone plastic bending deformation, but appeared to have fractured in a brittle manner, leaving matt fracture surfaces (Figure 8). The thickness of the plates at the level of the fracture was equal to the thickness stated by the manufacturer at 1.5 mm.

Figure 7: Retrieved broken VariAx plate (case 2) demonstrating transverse fracture of the plate at the sides of the screw hole.
