Investigating Ageing Process of Die Cast Aluminum in Squirrel Cage Rotors Exposed to Heavy-Duty Load Conditions

Constantin Pitis^{1,*} and Zaid Al-Chalabi²

¹ Powertech Labs. Inc. Canada

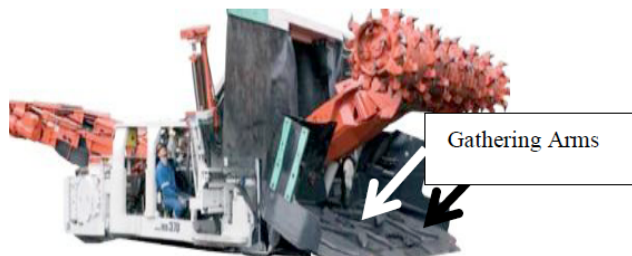
Figure 1: Typical 600 kW underground CM (courtesy of Sandvik Mining – Netherlands).

Applications requiring heavy duty load conditions are mostly found in underground mining (explosion-proof environment) and heavy industries. One of typical examples represents the underground cutting coal continuous miner (CM) - cutting and bolting machine, as shown in Figure 1.

The paper focuses on a 50 hp gathering arm SCIM (marked by arrows in Figure 1) which recorded high failure rate with mean time to the first failure of $T_{New, 0} = 5380$ h/y, while on the repaired motors $T_{Repair, 0} = 3770$ h/y resulting in notable negative financial effect on the business.

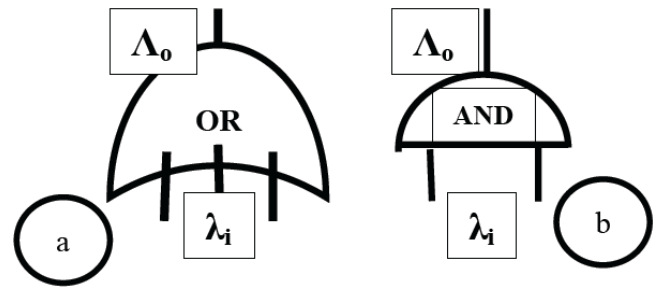
Figure 2: Graphical Description of gate “OR” and gate “AND”.

The “OR” gate showed in Figure 2a express the idea that ANY of several component failures can cause output event i.e. TE = equipment or process failure.

The gate “AND” showed in Figure 2b express the idea that both (or all) components must fail in order to produce the output event. The output event failure rate Λ_0 is therefore a function of LLE failure rates λ_i and can be calculated as:

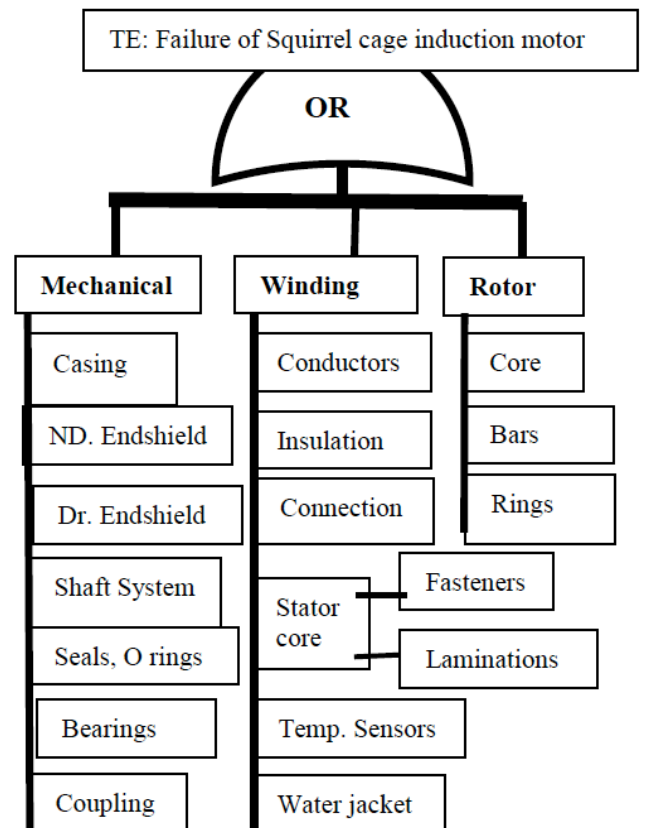
Figure 3: Simplified FTM graph for a typical water-cooled SCIM.

A basic FTM graph, as shown in Figure 3, was used to analyze reliability indicators for a water-cooled squirrel cage induction motor WC-SCIM.

As a method of combining various component failure rates, the fault tree breaks down top event (TE) – that is considered to be WC-SCIM failure, into lower-level events (LLE) as failures of various components.

Mechanical components, winding and rotor failures are considered the first LLE tier connected by “OR” gate, meaning any of them can produce TE.

Under Mechanical, Winding and Rotor LLE, there are second tier of LLE components, but for simplicity, the diagram does not indicate their “AND” and “OR” logical connections.

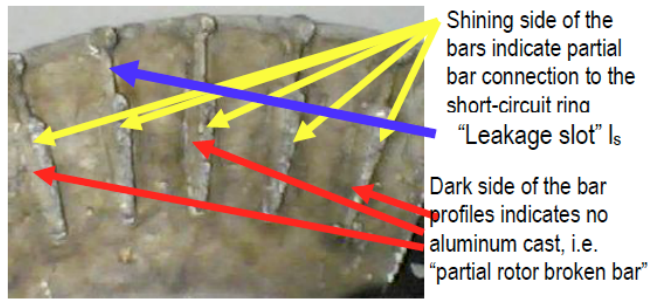
Figure 4: Leakage slot (Boucherot type) connects starting and running cages; due to TMS and quality of cast partial rotor broken bars might be present.

reason, DCAR Boucherot slot types (resembling double cage configuration) are preferred option. In a typical configuration, a leakage slot (I_s) is situated between running and starting cages, as shown in Figure 4.

These rotor types require leakage slot (between starting and running cages) yielding large reactance in order to prevent the main flux from missing the running cage bars [4]. During the casting process, an aluminum fillet enters in the leakage slot connecting the upper and the lower parts of the slot. Due to slot configuration the material in the leakage slot fillet is subject of approximate the same induction flux density as the top filament, while the current density performs discontinuities at the both ends of the leakage slot. This could be one of the reasons that, the leakage slot becomes the subject of intense TMS, defining a weak point of the electrical circuit of the rotor [5]. Rotor bar deformations with motor in steady state situations (blocked rotor and various slip values) have been studied and modeled by using Finite Element Method (FEM) [6].

It was demonstrated the heavy-duty load conditions generates high values current densities in the leakage slot producing high temperature gradients of 20°C/sec or higher that are superimposed on the temperatures due to rated conditions [5]. Due to short period of occurrence, these consecutive stresses determine a quasi-adiabatic cumulative thermal effect. As a result radial and longitudinal TMS are present in the rotor bars, as shown in Figure 4 and 6.

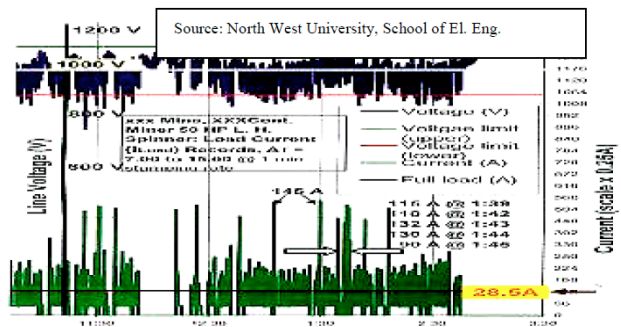
Figure 5: Typical pattern of heavy duty loading (stator current).

Site measurements recorded stator currents on 50 hp, 50 Hz, 1000 V, water-cooled, SCIM proved existence of such load types. A typical example is shown in Figure 5 (blank arrows) depicting repetitive pattern of 5 (five) almost consecutive stresses (loads)

on stator (rotor) currents with 1’23” time duration occurring in an interval of 29 minutes, as indicated in Table 5.

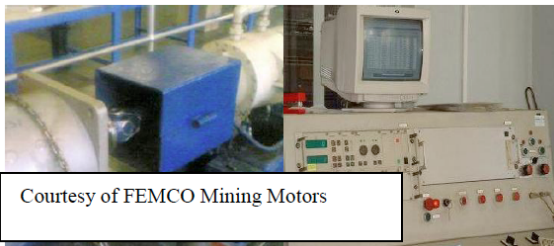
Figure 7: Dyno test bench - sample of test records.

At sponsor request, a series of tests have been performed on 20 new shipments motors and 12 first

TH1+TH2= 16.23428	OUT.WAT= 23.2244	CAGING= 54.6134	DRIVE= 57.3514
N/DRIVE= 60.4614	AMENT= 17.6758	I1= 31.3779	I2= 31.0094
I3= 31.7323	V1= 963.48	V2= 961.94	V3= 958.75
TORQ= 237.27	RPM= 1438.32	HZ= 49.9951	COS C= 0.854603
KVA= 52.240	INPUTKW= 43.600	SLIP= 61.6807	AVE V= 961.39
AVE I= 31.3732	T/RISE= 102.8491	R1= 1.163200	R2= 1.610000
T1= 22.0000	NoLD.I= 13.2000	NoLD.KW= 2.20000	IrFLOGG= 1.78289
CoLOSS= 2.37703	ADDLOSS= 0.189091	A.GAP= 39.440	RO.C.LS= 1.62179
OUTPUT= 37.629	EFF.= 86.305	OUTP.ID= 35.735	EFF.TQ= 81.961
AX.VIBR= 1.20000	VT.VIBR= 2.10000	HR.VIBR= 2.50000	NDEVIBR= 3.60000
FLOW= 4.000	DIF.T/R= 0.63274	DIF.R/S= 1.35077	DIF.S/T= -1.95315

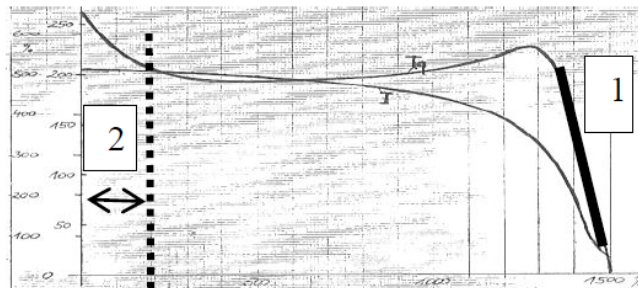
Figure 8: Speed–Torque Curve on new motor (dyno test); motor doesn't have a “D” design rotor!

time repaired motors (Figure 7). Speed – torque curve has been investigated (figure 8) and found the rotor not being “D” type design. Other tests performed: heat run test recording and confirming rated values and temperature rise of different components and cooling agent, overload tests, temperature differential values across drive and non-drive bearings in stabilized hot condition and overload, starting torque and current in cold and hot condition.

- The motor running interval tends to move from stable interval (1) = 1500...1300 rpm to large slip values in interval (2) = 0...200 rpm as dash-marked on Figure 8 where high values of TMS are present [5, 6].

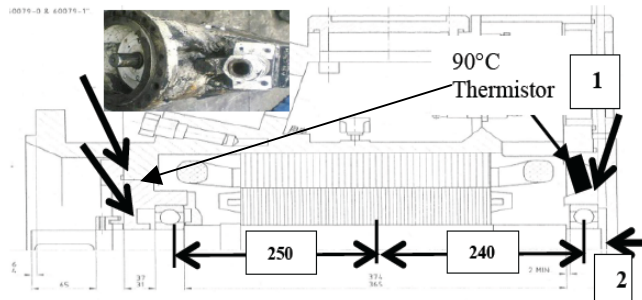
Figure 9: Cross section of 50 hp motor.

The motor is equipped with 2 x 6311 C3 bearings with $d = 55 \text{ mm}$, $D = 120 \text{ mm}$, $B = 29 \text{ mm}$, ball radius $r = 0.011 \text{ m}$, mass $m = 1.35 \text{ kg}$, average C3 clearance $S @ 25 \text{ }^\circ\text{C} = 60 \text{ }\mu\text{m}$, specific heat $C = 0.49 \text{ kJ/kg }^\circ\text{C}$, thermal conductivities (bearing – $K_B = 0.006 \text{ kJ/mm sec }^\circ\text{C}$, shaft – $K_S = 0.060 \text{ kJ/mm sec }^\circ\text{C}$), linear expansion coefficient $\lambda = 15.7 \text{ exp }(-6)$ [7]. The NDE bearing is positioned at 240 mm from the rotor center, DE bearing positioned at 250 mm from the rotor center and shaft to thermistor $x = 275 \text{ mm}$ (Figure 9). Two RTDs have been installed in points “1” (outer race) and “2” (inner race) monitoring the temperature gradient (Figure 10).

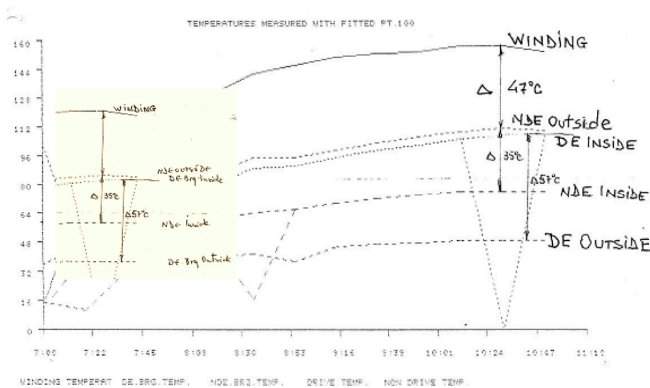
Figure 10: Temperature records and temperature differential values across drive bearings (51 C) and non-drive bearings (35 C) during load condition (enlarged detail on the left hand medallion).

At thermal equilibrium ($\Delta T_{NDE} = 55^\circ\text{C}$) the NDE bearing absorbed 2.22% of the rotor heat (3) keeping same clearance

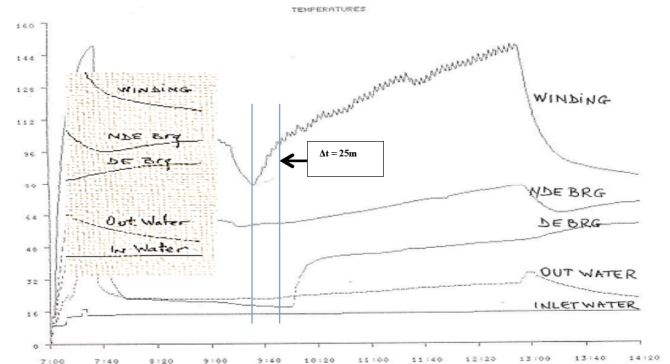
Figure 11: Temperatures evolution during simulation of heavy-duty load on dyno (enlarged detail on the left hand medallion).

A steady 36 kW load has been applied when SCIM temperatures were stable at: NDE = 65°C, Winding = 80°C. The RTD installed in close proximity of 90°C thermistor start reacting after about 25 minutes (Figure 11).

Thus for time duration from rotor to point “2” is $t_{R,2} \approx 3.5 \text{ min}$, while time duration from point “2” to thermistor is $t_{2,Th} \approx 20 \text{ min}$. Total calculated time transfer is $\Delta t = 23.5 \text{ min}$ is confirmed by experiment indicating $\Delta t \approx 25 \text{ min}$ (Figure 11).
