Reinforcement of GFRP Tensile Specimens with Central Holes Using Bonded Composite Patches

Abstract: The use of bonded composite patches is a promising repair/reinforcement method to extend service life of damaged structures. These patches are non-corroding, lightweight, easy to fabricate and have high specific modulus and strength. In this work, the tensile behavior of a patch-reinforced composite specimen with a central hole is analyzed experimentally. A 10-ply composite tensile specimen is prepared by using bidirectional woven e-glass fabric and epoxy resin as the matrix material. The damage is created in the specimen by drilling three different holes with 3, 6 and 10 mm diameter at the center. The specimen is then reinforced by bonding composite patches or carbon steel patches with different lengths as external patches on both external surfaces. Tensile tests have been carried out on the undamaged, damaged, and repaired specimens. From the tensile tests, it was possible to verify the reduction of the strength (measured by the rupture force) of the specimens with holes of 3 mm, 6 mm and 10 mm. The patches were manufactured using the same glass fiber reinforced plastic, GFRP, use

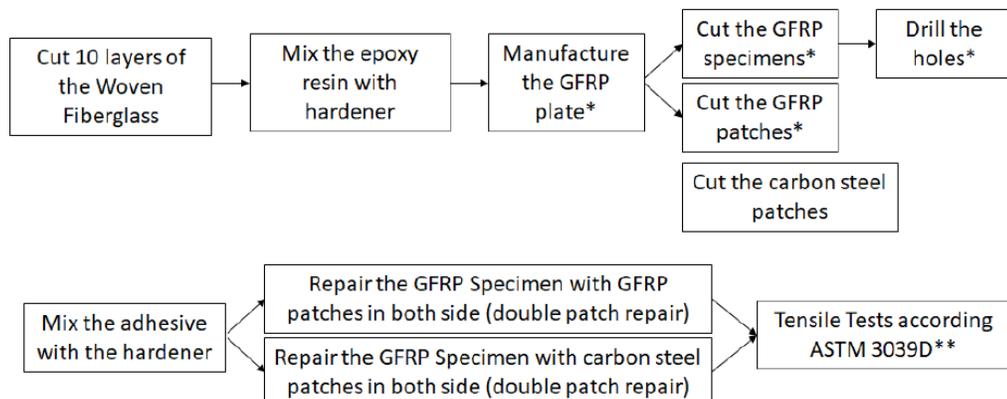
Figure 1: Flow Diagram.

The Figure 1 is a flow diagram of all steps before and after the tensile test according to ASTM 3039D.

*visual inspection before the tensile test
 **visual inspection after the tensile test

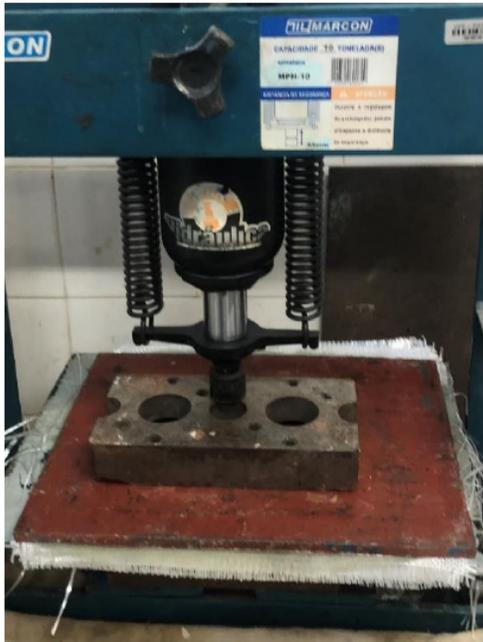
Figure 2: Press used to manufacture the GFRP plate.

should only be used after applying the resin. The third point is about the force applied by the roller. The applicator must be careful not to overdo it and damage the fibers. Figure 2 shows the press used to manufacture the GFRP plate. The stacking was done between two metal plates and TECGLAZE[®] wax base was used as a release agent. The stack was placed in a press to ensure the specimens were 2.5 mm thick.

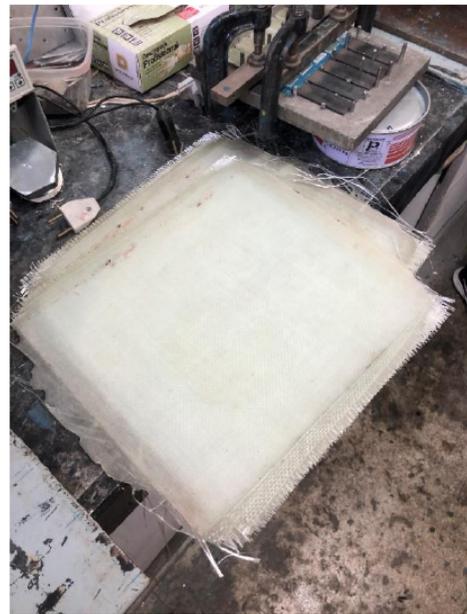
Figure 3: GFRP plate after 7 days cure.

The plates were only demolded after 7 days of curing at room temperature. There was no difficulty in removing the mold as wax was applied. The plates were again visually inspected for defects. No delamination or lack of resin were detected in the surface layers. Figure 3 shows the plate after a 7 days cure.

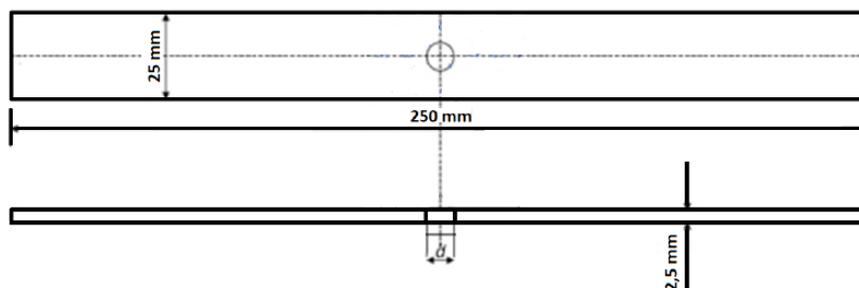
Figure 4: GFRP specimen dimensions.

after cutting with a caliper to ensure they were manufactured according to ASTM D3039. The GFRP patches were also measured to ensure they were manufactured according to specifications. The GFRP specimen dimensions are presented in Figure 4.

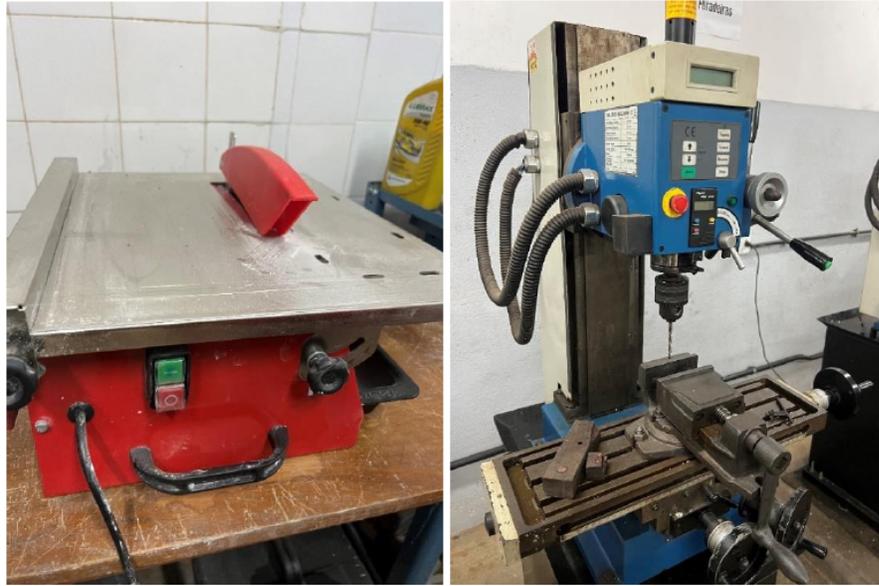
Figure 5: Bench saw and bench drill.

The holes in the specimens were made with a bench drill shown in Figure 5. A piece of wood was used to avoid delamination at the end of drilling for

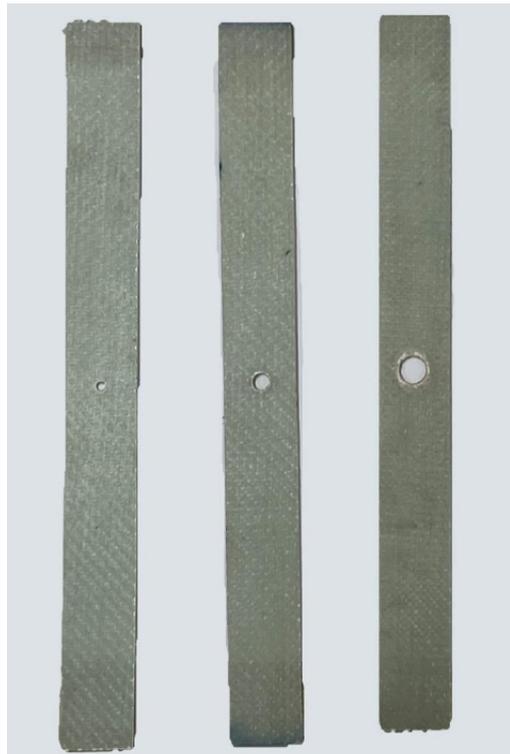
Figure 6: Specimens with 3 mm, 6 mm and 10 mm holes.

The specimens drilled with 3 mm, 6 mm and 10 mm holes are shown in Figure 6.

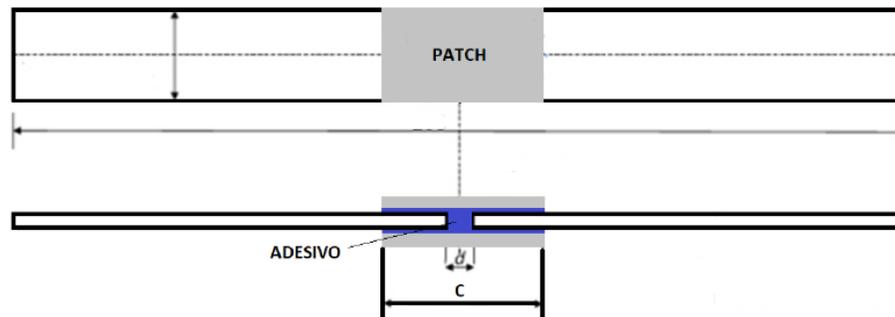
Figure 7: Adhesive repair using carbon steel patches and GFRP patches.

manufacture the specimens. The carbon steel patches were manufactured using a carbon steel plate. Only the carbon steel patches had surface treatment. The centers of the patches were positioned in the centers of the specimens. No surface treatments or roughness measurements were made on the specimens or patches.

The adhesive mixing and patch applications were done completely manually as shown in Figure 7.

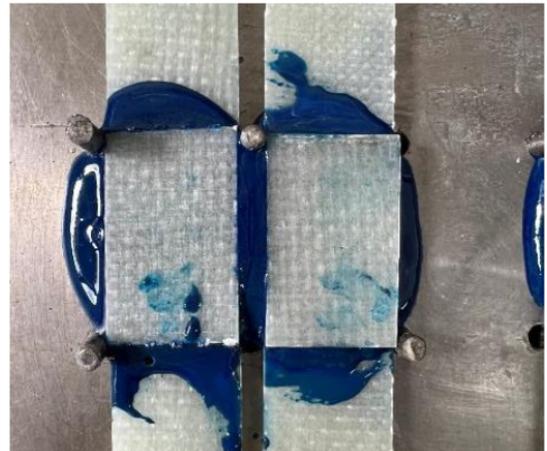
Figure 10: GFRP specimens after adhesive application and before cure.

Figure 9 shows the GFRP specimens after adhesive application and before cure. After curing for 7 days (Figure 10), the average thickness of the films was 0.37

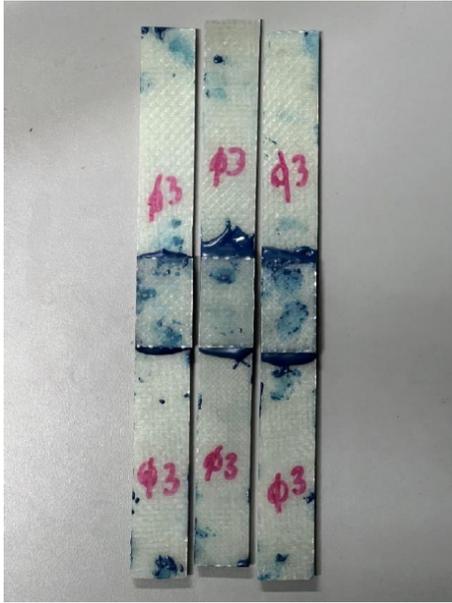
Figure 11: GFRP Specimens with GRFP patches ready for test.

The tensile tests followed the ASTM D3039 standard, which establishes the parameters and requirements for tests with composites. The equipment used to carry out the tests was the SHIMADZU® model AG-X machine. To position the specimen, the machine's standard clamps were used to clamp the ends of the specimens. The distance between the claws was 160 mm (Figure 11).

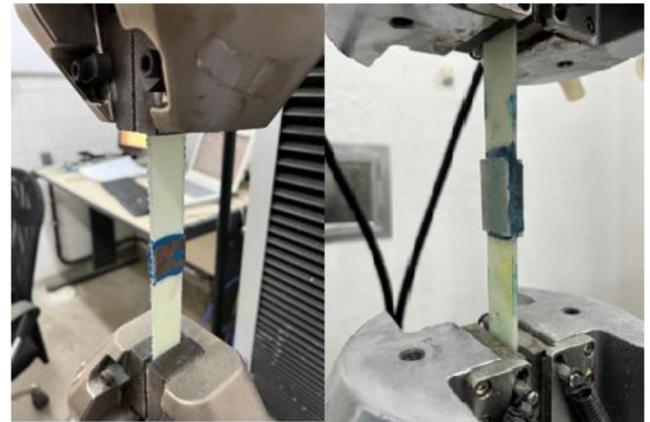
Figure 12: Tensile tests with carbon steel and GFRP patches.

The higher results for holes with 3 mm and 6 mm diameters are the GFRP patch with 40 mm of length. The higher result for hole with 10 mm is the repair with a GFRP patch with 60 mm of length. Figures 12, 13 and 14 present typical stress strain curves for different situations.

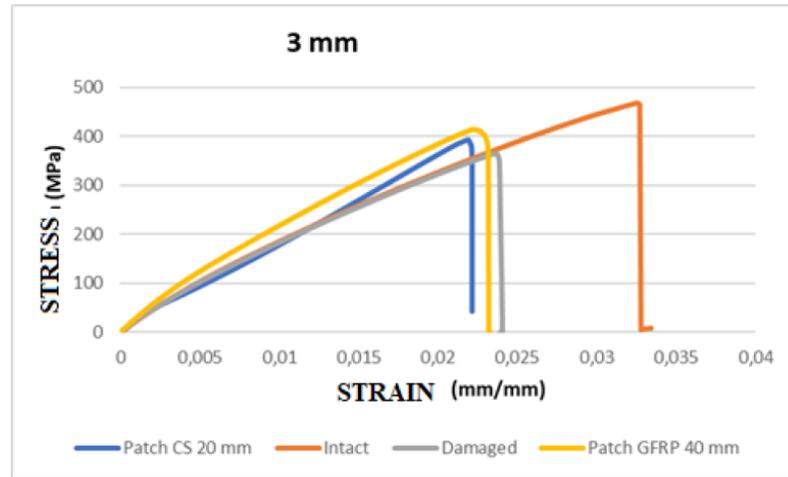
Figure 13: Stress vs strain curves for specimens with a 3 mm hole.

For holes with 3 mm and 6 mm diameter, the higher results for carbon steel were patches with 20 mm of

length. For hole with 10 mm, the higher result was patch with 40 mm of length. The results of carbon steel patches were inferior to GFRP patches.

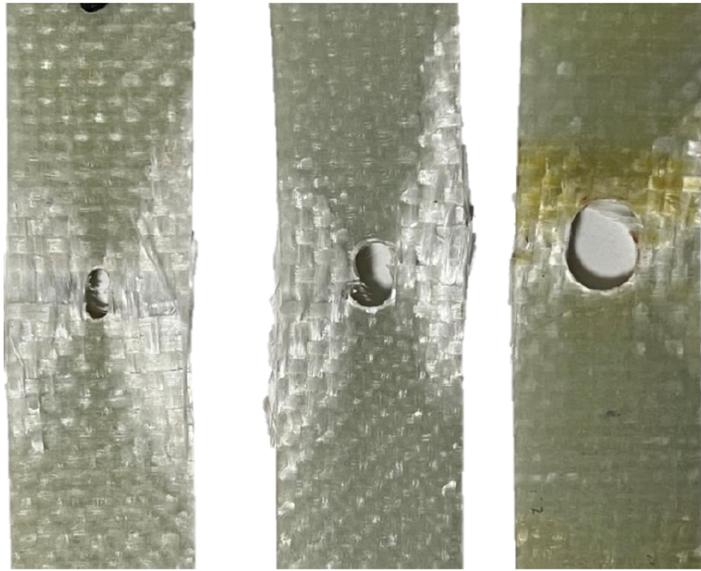
Figure 16: Specimens after Tensile Tests.

As expected, the highest concentrations were around the 10 mm hole. Layer delamination, fiber breakage and matrix fracture were detected after the

conclusion of the tests. In Figure 15, a photo of the damaged test specimens is shown after carrying out the tests without repair.

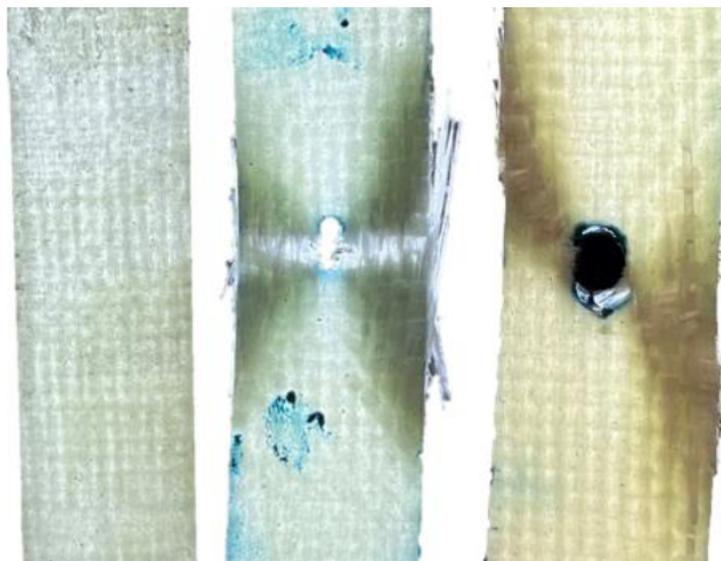
Figure 17: Specimens Illuminated with a Flashlight.

The specimens were illuminated with a flashlight before the tests and afterwards to visually check the presence of delamination, fiber breaks, lack of resins and impurities in the intermediate layers. Below are photos in Figure 16 of these records.

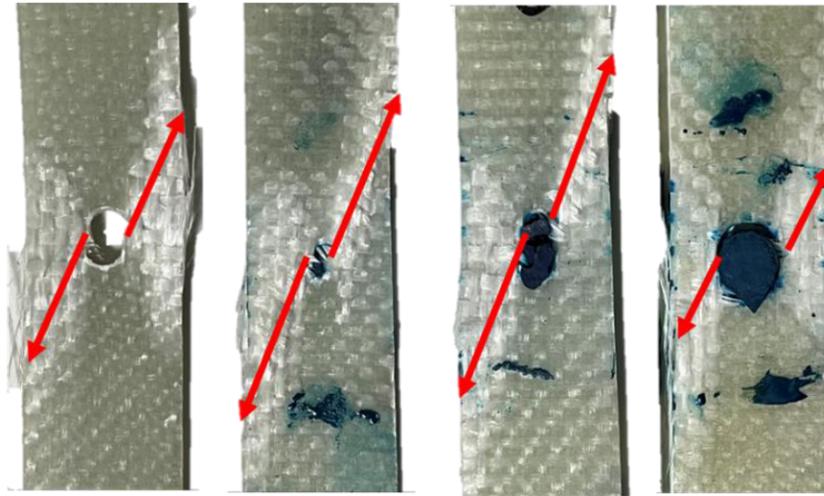
Figure 18: Type I Crack Propagation Direction.

There are only records of delamination, fiber breaks and matrix fractures after tensile tests. Two different directions for crack propagation were observed. In Figure 17, the first configuration. In these cases, less

delamination and fewer broken fibers were observed.

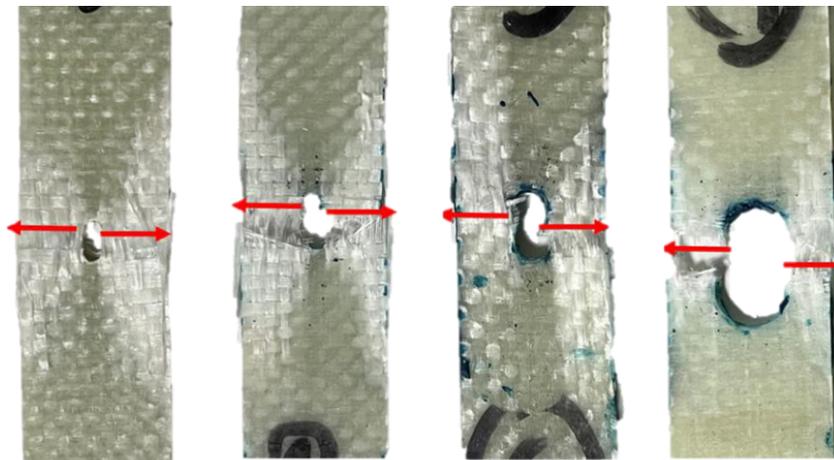
Figure 19: Type II Crack Propagation Direction.

In Figure 19, the second configuration. In these cases, it was observed that the delamination was longer, and the fibers broke much more. Some specimens even broke completely.

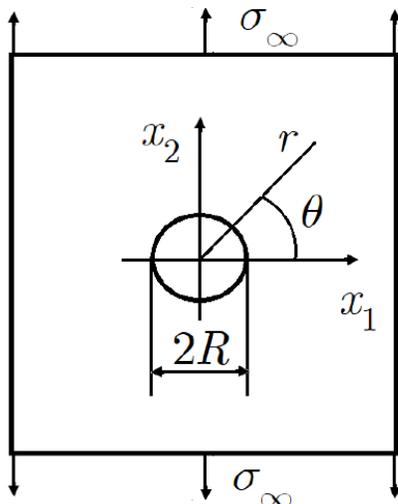
Figure 20: Tensile test of an orthotropic plate with a circular hole.

Although it is not the goal of the present study, it is interesting to make some remarks about the stress distribution and failure criteria. Figure 19 shows an orthotropic plate with a circular hole under traction. x_1 and x_2 are the fiber directions. The hole diameter is noted R . The laminate stress along fiber direction is usually noted $\sigma_{11}(x_1, x_2)$. The laminate stress

transverse to fiber direction is usually noted $\sigma_{22}(x_1, x_2)$ and the laminate shear stress is usually noted $\sigma_{12}(x_1, x_2)$.

Eventually it is more interesting to express the stress tensor components in polar coordinates: $\sigma_{\theta\theta}(r, \theta)$, $\sigma_{r\theta}(r, \theta)$ and $\sigma_{rr}(r, \theta)$. A classical boundary condition implies that the forces applied on the boundary of the hole must be equal to the product between the stress tensor and the unit outward normal vector. Since there are no external forces acting on the external surface of the hole, it comes that
